# CASE STUDIES FROM THE LAST 5 YEARS' RESTORATION PROJECTS OF HISTORIC MONUMENTS IN SOPRON

Sándor TÁRKÁNYI

*University of Sopron, Faculty of Wood Engineering and Creative Industries. Sopron, Hungary.  
tarkanyi.sandor@uni-sopron.hu*

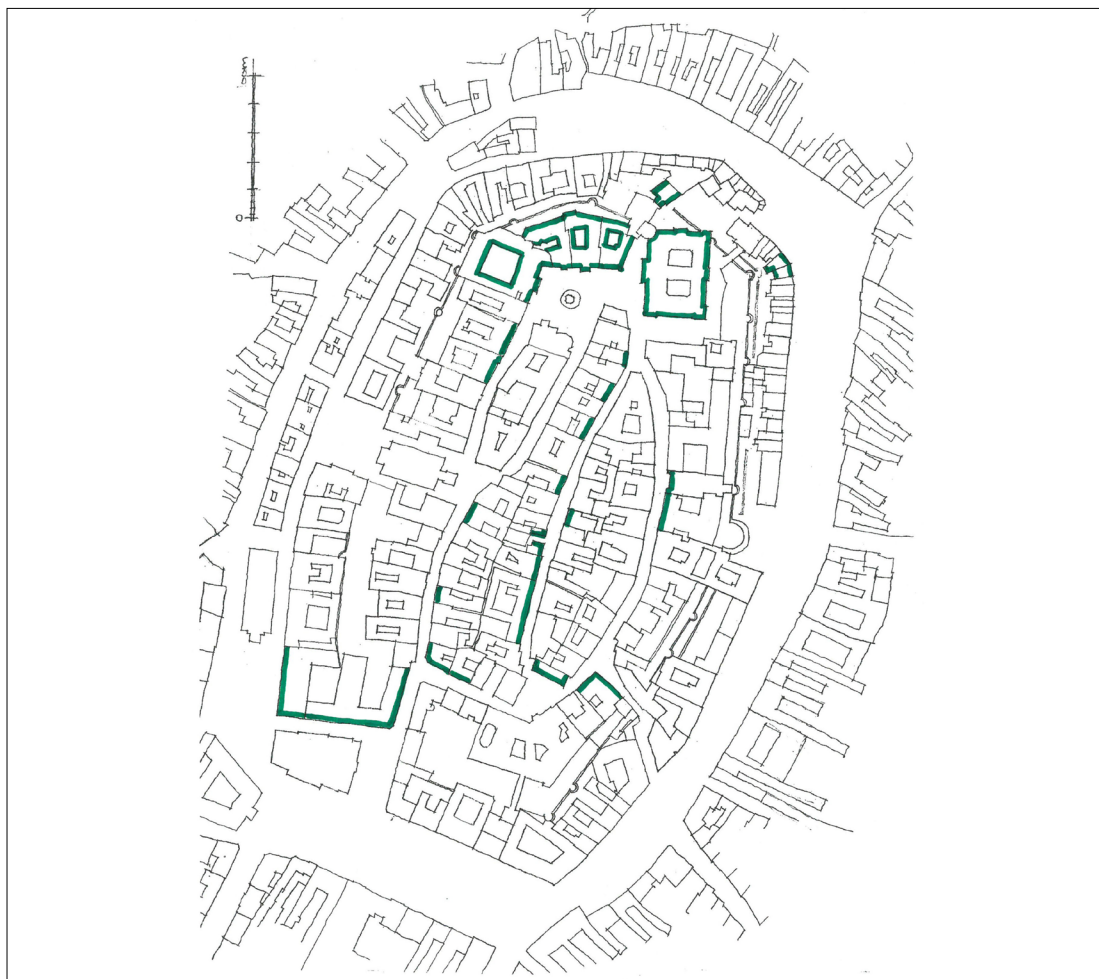
**Figure 1.** A MCP Building restorations within the baroque downtown area of Sopron. Bold lines represent the restored façades. (Drawing made by András Veöreös and Sándor Tárkányi).

The 25 buildings whose (mostly) street-facing façades were renovated through the program were, as follows: 1 Fő square, 2 Hátsókapu, 5 Orsolya square, 3 Petőfi square, 7 and 9 St. György street, 2, 4, 7, 15, 21 and 26 Templom street, 4, 8, 11, 12, 14, 16, 22-24, 26 and 28 Új street, 54-56 Várkerület. (see [Figure 1](#)).

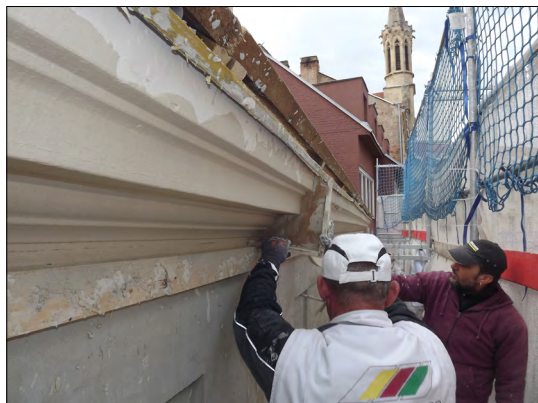
**Figure 2.** Moulding the fascia of the St. György street façade of 2 Hátsókapu, using a mould knife (author's photograph).

On March 28, 2019, the contractor submitted another alteration notice, this time regarding the plaster system to be applied. Instead of the Keim Porosan repair plaster named in the budget, he wanted to use the MC OXAL DS-HS insulation sludge up to a height of 1.5 metres (or 20 cm of above the adjacent terrain). Above this level, he wanted to use the LB-Knauf Eurosan plaster system. Above 1.5 m, LB-Knauf Kontakt sprinkle sub-plastering and Premium base were to be used. The administrator approved the alteration notice (Figure 2).

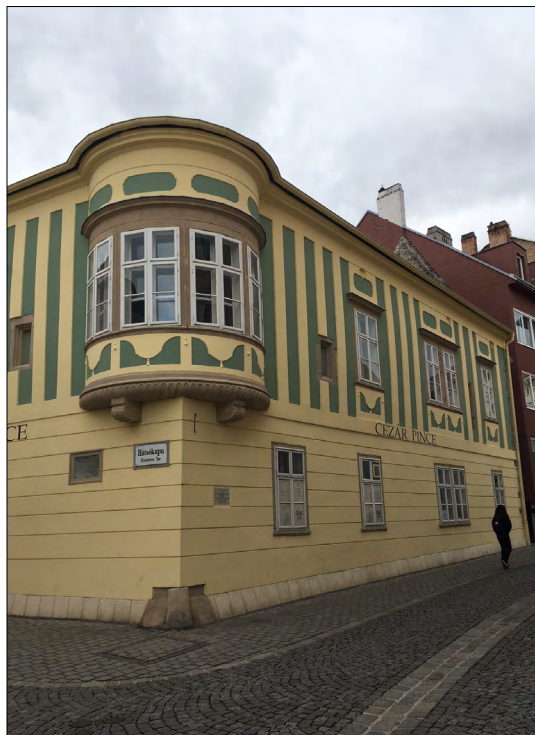
**Figure 3.** A section of the restored façade of the 2 Hátsókapu building, as seen from St. György street. (author's photograph)

on June 7, 2019, overseen by the representative of the Agency and that of the contractor. The heritage protection administrator inspected the completed façade paint and roofing materials from the scaffolding. The contractor has done first rate work, and thus the scaffolding could be dismantled (see **Figure 3**). The Agency's representative asked that pigeon spikes would be installed on the sill of the medieval stone window frames. The contractor accepted this job.

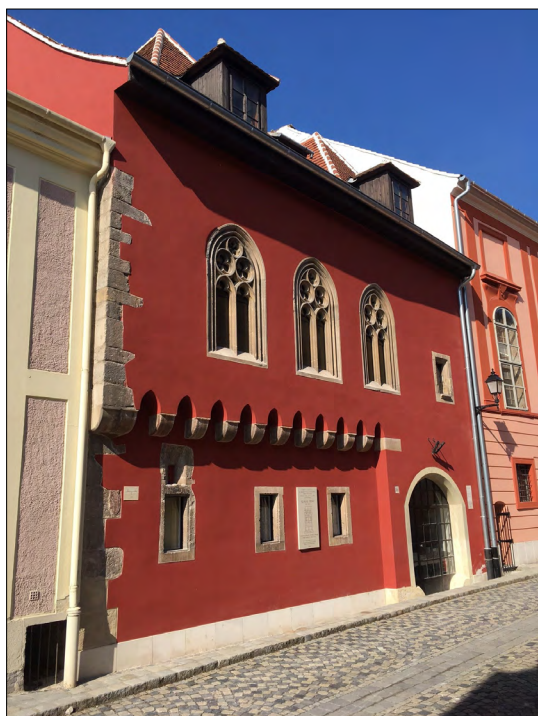
The contractor deviated from the approved construction plan during the renovations on two occasions. Instead of using a tainted skim coat on the façade, they used white plaster, and instead of lime plaster they used paint. Due to the white skim coat, small façade damages show very prominently. The other deviation was a positive one, namely, installing new gutters instead of painting the old ones (Figure 4).

**Figure 4.** The restored street-facing façade of 16 Új street (author's photograph)

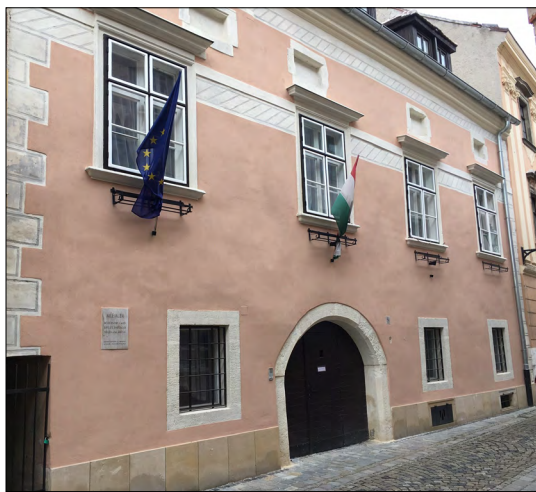
Based on the results, errors and flawed decisions made in the earlier renovation of the building were corrected during the recent restoration. The street-facing façade went through exemplary restoration due to the contractor's conscientious and circumspect work and co-operation with the authorities and experts (Figure 5).

**Figure 5.** The restored street-facing façade of 8 Új street. (author's photograph)

- renovation (cleaning, conservation, restoration, minimal supplementing where needed) of the sgraffito-ornamented surfaces;
- after conservation, amorphous witness façade surfaces should be covered with the help of an expert restorer, to create an uninterrupted façade surface. This will create a pleasing façade appearance.

Based on the report, the contractor modified the materials and technologies to be used for the renovation, which was approved by the Agency. On July 10, 2019, the final colours of the façade were chosen based on the sample colouring applied to the façade earlier. This included the base colouring, as well as sgraffito, stone framework and main ledge colours.
