## BUDAPEST, III. KERÜLET, JUTAS UTCA 84. (HRSZ. 22185)

### Lakóház és garázs építése

## BUDAPEST, DISTRICT III, 84 JUTAS STREET (PLOT NO. 22185)

### Construction of a residential building with a garage

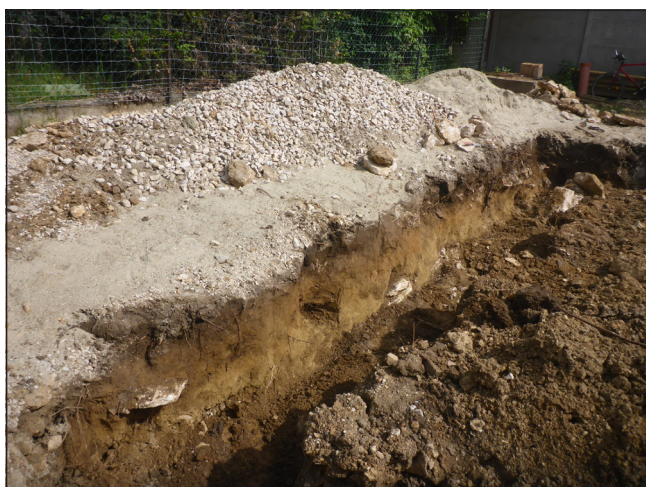
1. kép: A garázs nyugati alapárka (Fotó: Gyenes Gábor)  
Fig. 1. Western foundation trench of the garage  
(Photo by Gábor Gyenes)

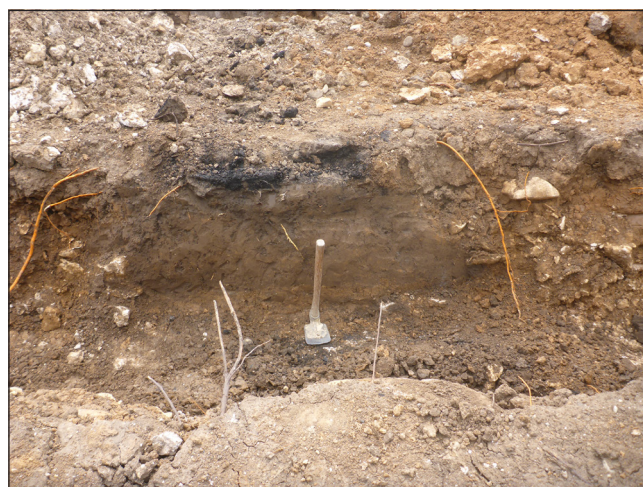
2. kép: Az ismeretlen korú beásás a garázs alapárkában  
(Fotó: Gyenes Gábor)  
Fig. 2. Feature of unknown date in the foundation trench of the garage (Photo by Gábor Gyenes)

dör betöltése összetömörödött sötétbarna, homogén, agyagos volt. Régészeti korú vagy újkori lelet nem volt benne, így a kora ismeretlen maradt. (2. kép)

In the central foundation trench of the garage, a circular pit with a diameter of 1.5 m was observed. On the excavation level, which here lay close to the surface, a burnt feature with charcoal-rich staining indicated a recent burning event. The fill consisted of compact, dark brown, homogeneous clay. No archaeological or modern artefacts were recovered from it, so its date remains unknown. (Fig.2)
